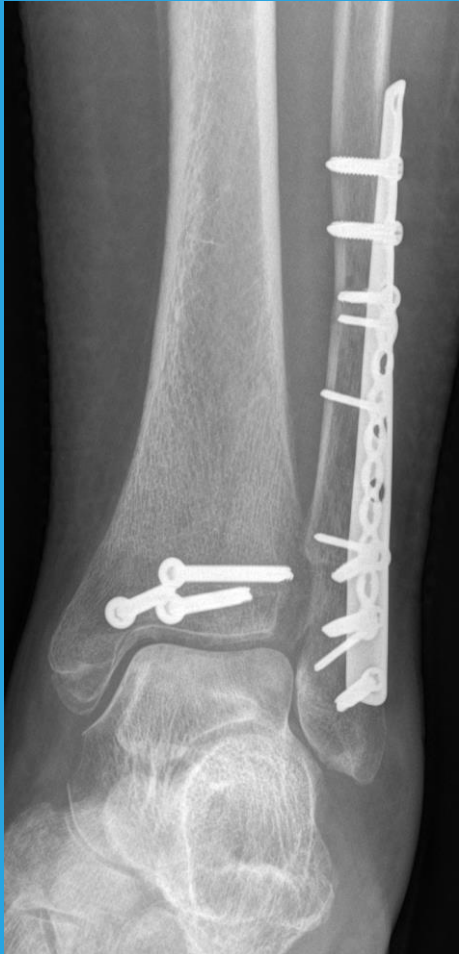
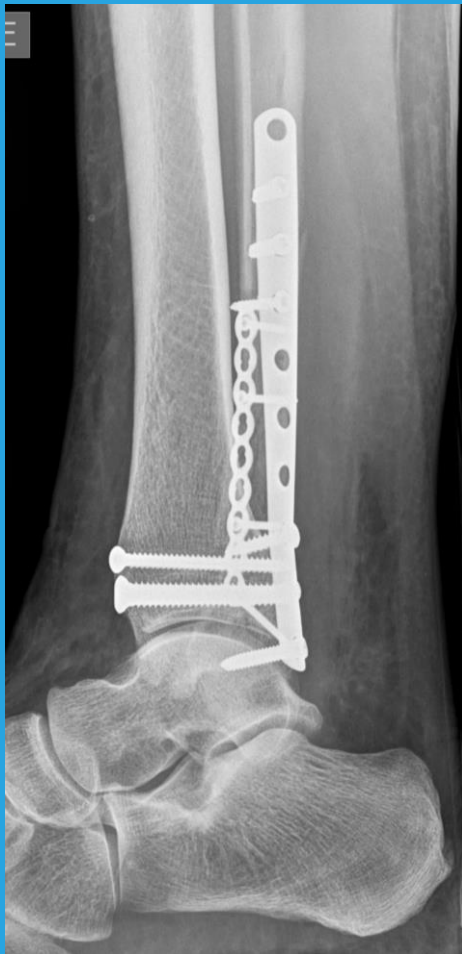
Patient presented with an ankle fracture dislocation that was reduced (put back into place) in the ER. Fracture of the fibula (smaller bone) required two plates which can be seen well in the second image. The posterior malleolus was fixed with three screws. If there is instability between the tibia and fibula (syndesmosis), an additional long screw between the two is needed. Stability of the syndesmosis is routinely checked after the fractures have been fixed and a syndesmotic screw was not needed.
