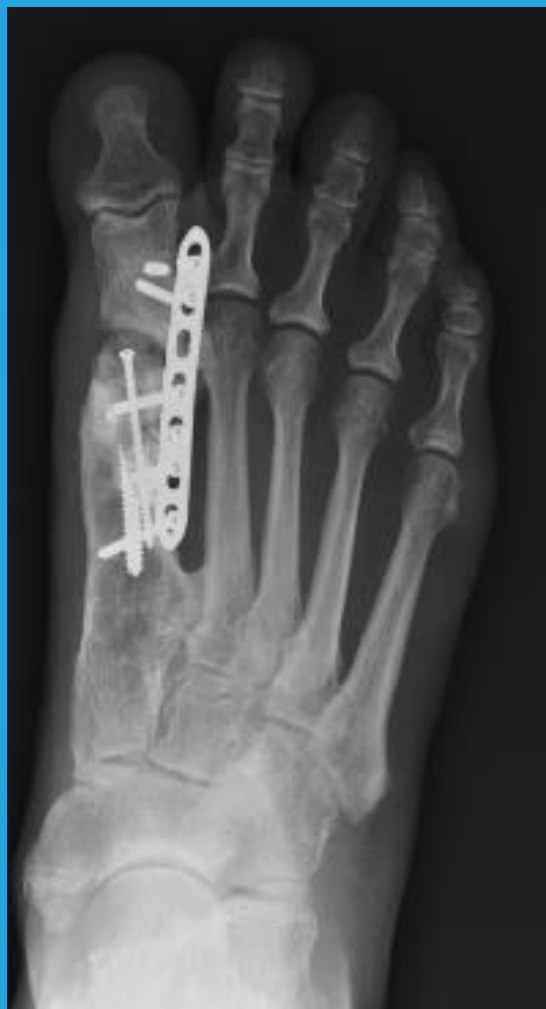
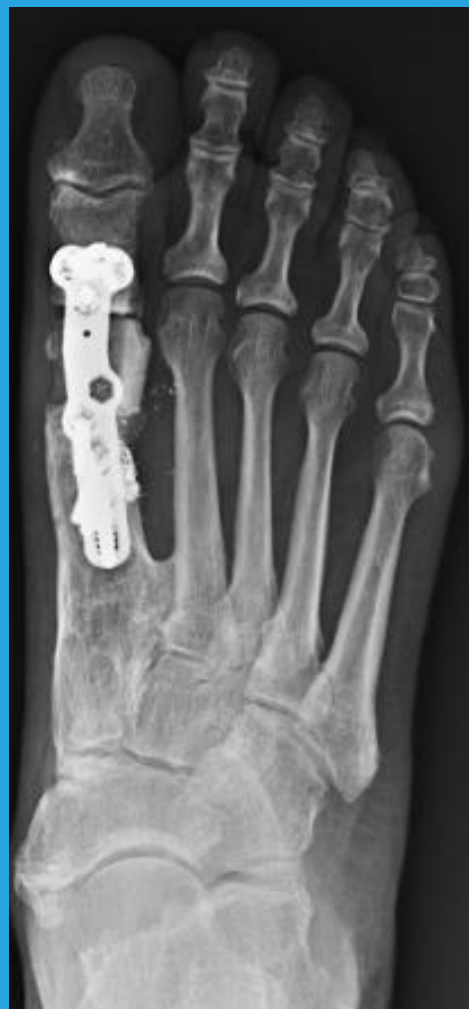
Multiple previous attempts at fusion of the large toe failed leading to significant bone loss. This required a large autograft from the patients pelvis to maintain length as well as a larger plate to restore the proper alignment and maintain length of the toe.
